DEFENDANTS' MOTION FOR SUMMARY JUDGMENT—EXHIBIT 2
RICHARD CLARKE EXPERT REPORT (JAN. 24, 2018)

Re: **Clarence Edward Whitaker. etc., v. Hyundai Motor America, Inc.**
2007 Hyundai Santa Fe
VIN: 5NMSH13E57H041555
Case # R-1128

Report of Investigation and Analysis

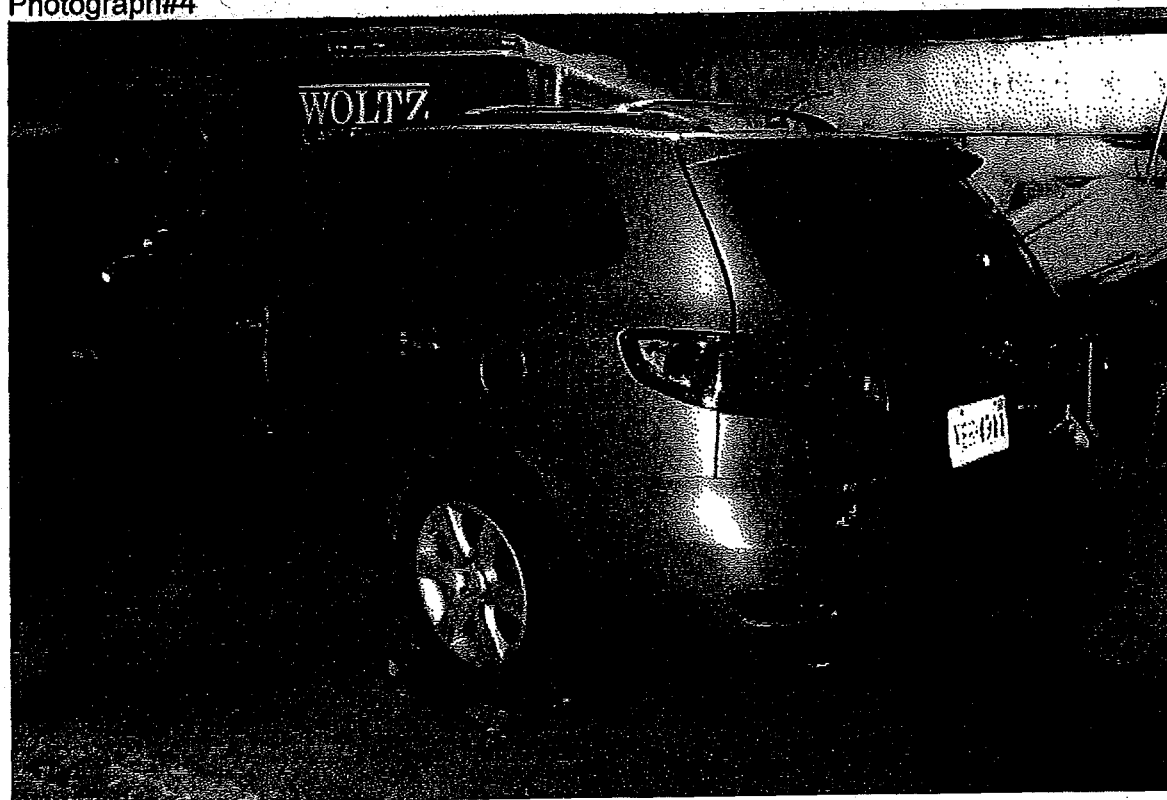
1. The preliminary inspection of the SV was performed on August 17, 2016 at a storage building in Venton Virginia, as shown in photograph 1. The Vehicle Identification Number, VIN # 5NMSH13E57H041555, as shown in photograph 2. The SV driver's door and fender revealed minor damage, photographs 3 & 4. The passenger side front door glass had been broken out, as shown in photograph 5.

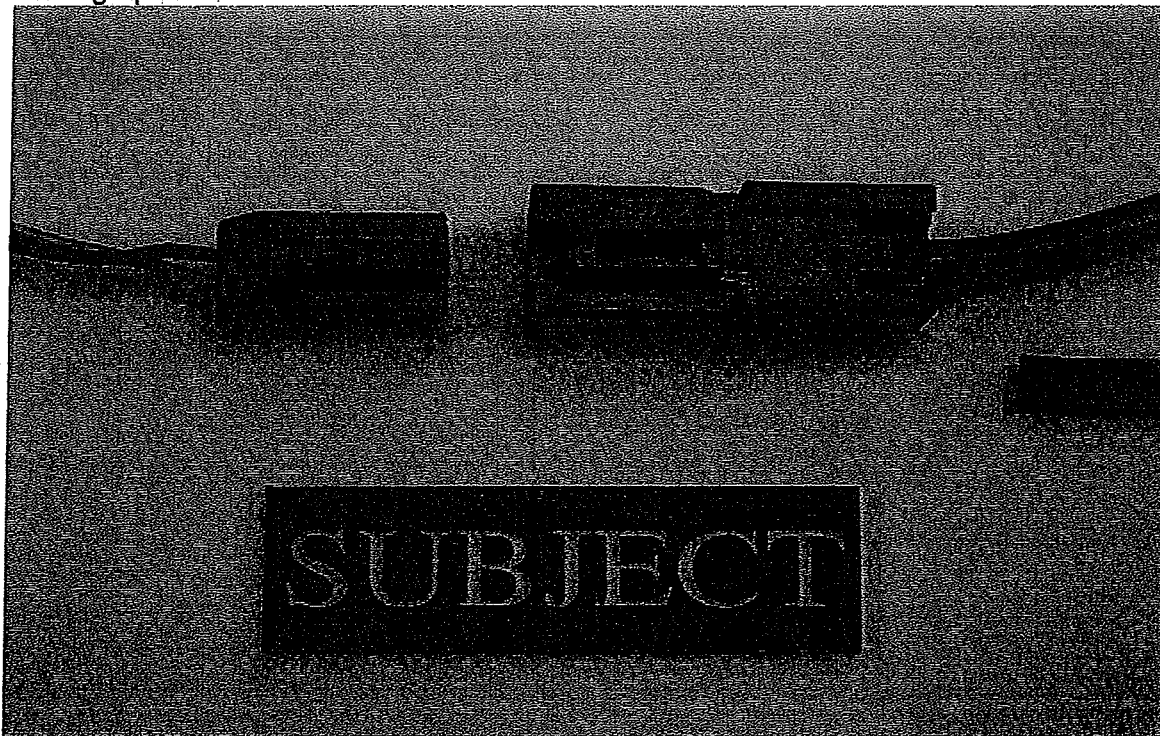
Photograph #15

2. Further analysis, disassembly and removal of the ignition interlock solenoid connector was performed at M.E.I. on January 10 & 11, 2018 the female and the male portion were removed, as shown in photograph 15. A new battery was installed in the SV, photographs 16 & 17.

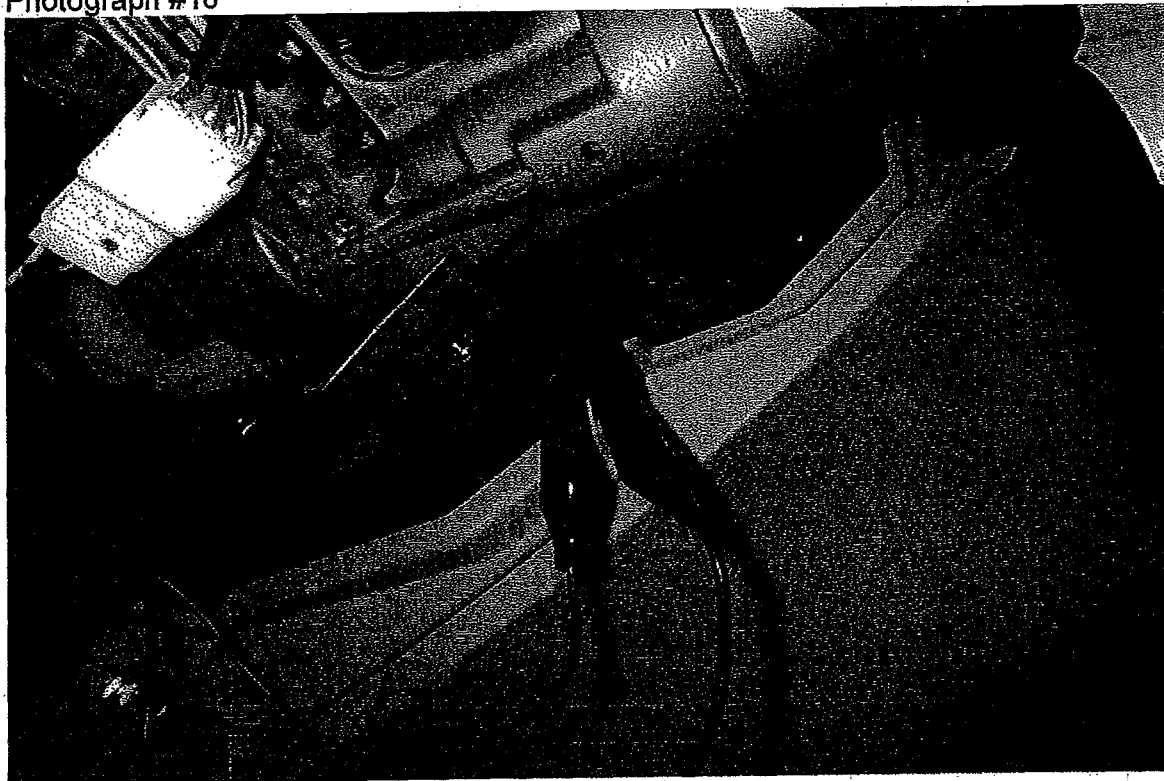
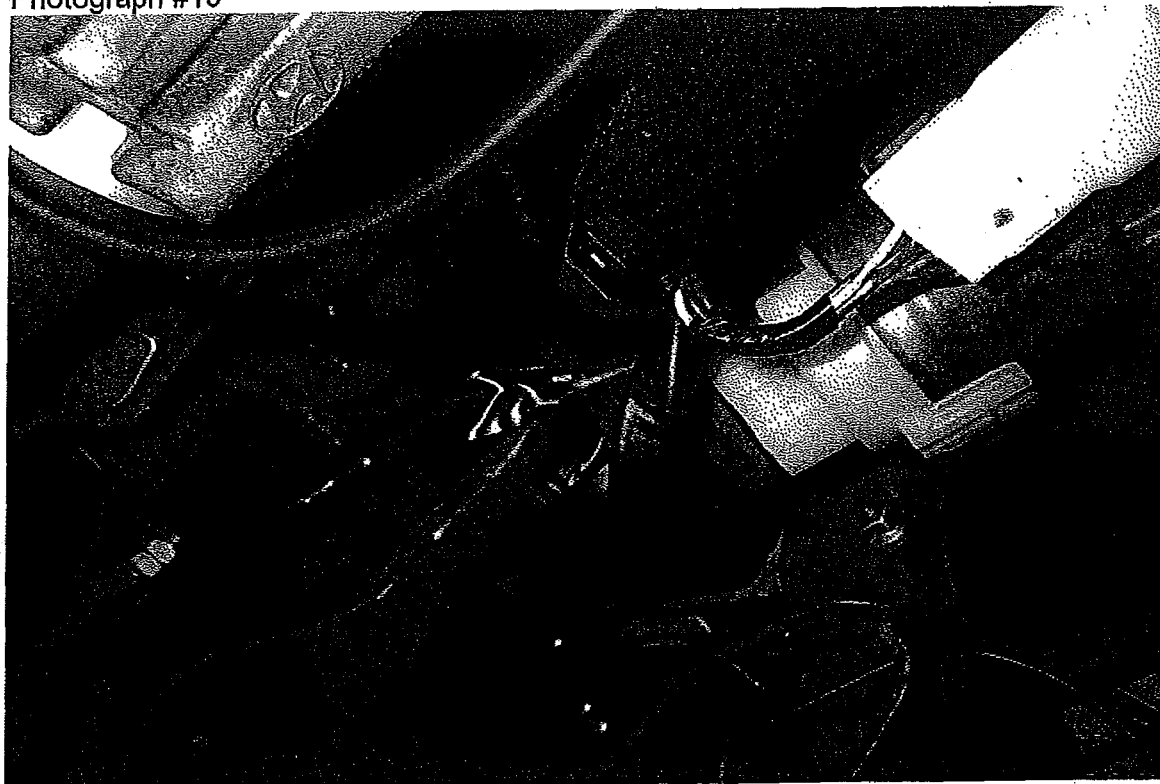
3. Jumper wires were connected on the sectioned SV wire harness to bypass the connector that was removed so the system could be tested, photographs 18 & 19. The jumper wires were connected and the ignition switch and the ignition interlock solenoid functioned as intended. The ignition key could only be removed when the gear shift lever was in Park (P) position.

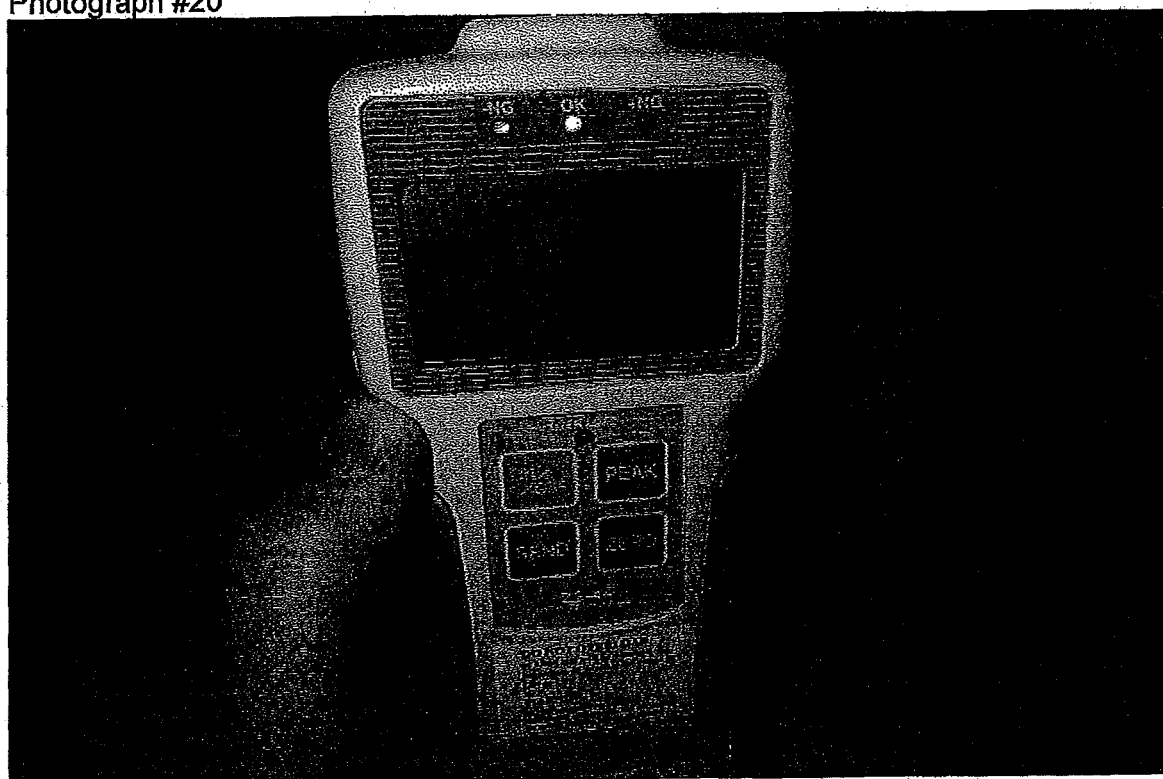
Photograph #20

4. Force measurements were conducted on the gear shift lever with the ignition interlock solenoid jumper wires in place and disconnected as per the test protocol. The forces were as low as 12.79 lbs and were recorded to pull the gear shift lever into Reverse (R), as shown in photograph 20. The gear shift lever assembly was removed and a small fragment of what appears to be the same material was found under the gear shift lever assembly, shown in photographs 21 & 22.
